Manhole Inspection Summary

Manhole # S09EE2021MH

Insp Date: **7/31/06 1:24 PM**

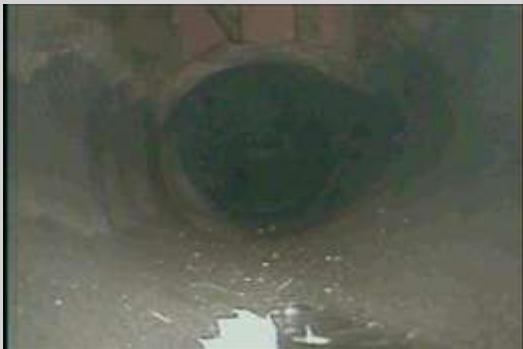
8 in. Circular Gravity Sewer Pipe In @ 6 O'Clock

Pipe Material: **Clay** ☐ Pipe Lined

Invert Depth: **8.91** (ft.) Flow Characteristics: **None**

Deposits: ☒ **None** ☐ Mud ☐ Sludge ☐ Debris ☐ Grease

Infiltration: **None** Pipe Seal Cond: **Sound**

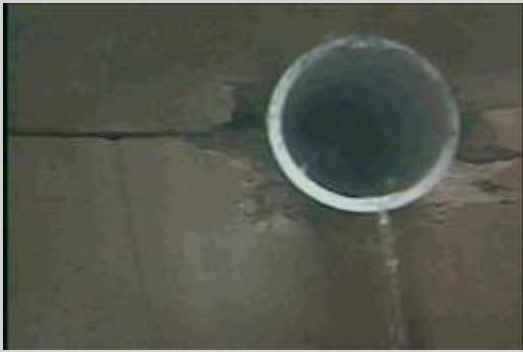
4 in. Circular Gravity Sewer

Pipe Material: **PVC**

Invert Depth: **4.36** (ft.) Flow Characteristics: **Slow**

Deposits: ☒ None ☐ Mud ☐ Sludge ☐ Debris ☐ Grease

Infiltration: **None**

Pipe Seal Cond: **Sound**

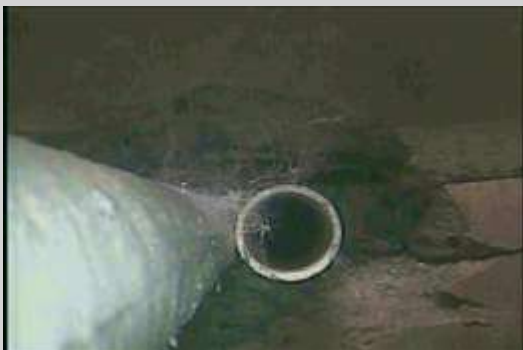
4 in. Circular Gravity Sewer

Pipe Material: **PVC**

Invert Depth: **4.36** (ft.) Flow Characteristics: **None**

Deposits: ☒ None ☐ Mud ☐ Sludge ☐ Debris ☐ Grease

Infiltration: **None**

Pipe Seal Cond: **Unknown**

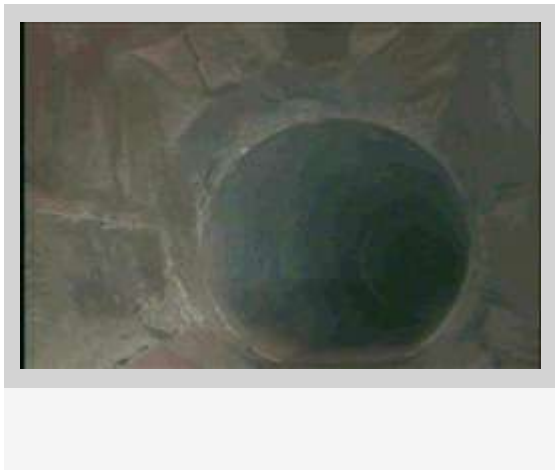
8 in. Circular Gravity Sewer
Pipe In @ 9 O'Clock

Pipe Material: **Clay** ☐ Pipe Lined

Infiltration: **None** Pipe Seal Cond: **Unknown**
